PHOTOGRAPHIC INTELLIGENCE REPORT

PROBABLE TA-TUNG DIESEL ENGINE PLANT #616

TA-TUNG, CHINA

CIA/FIR 65113

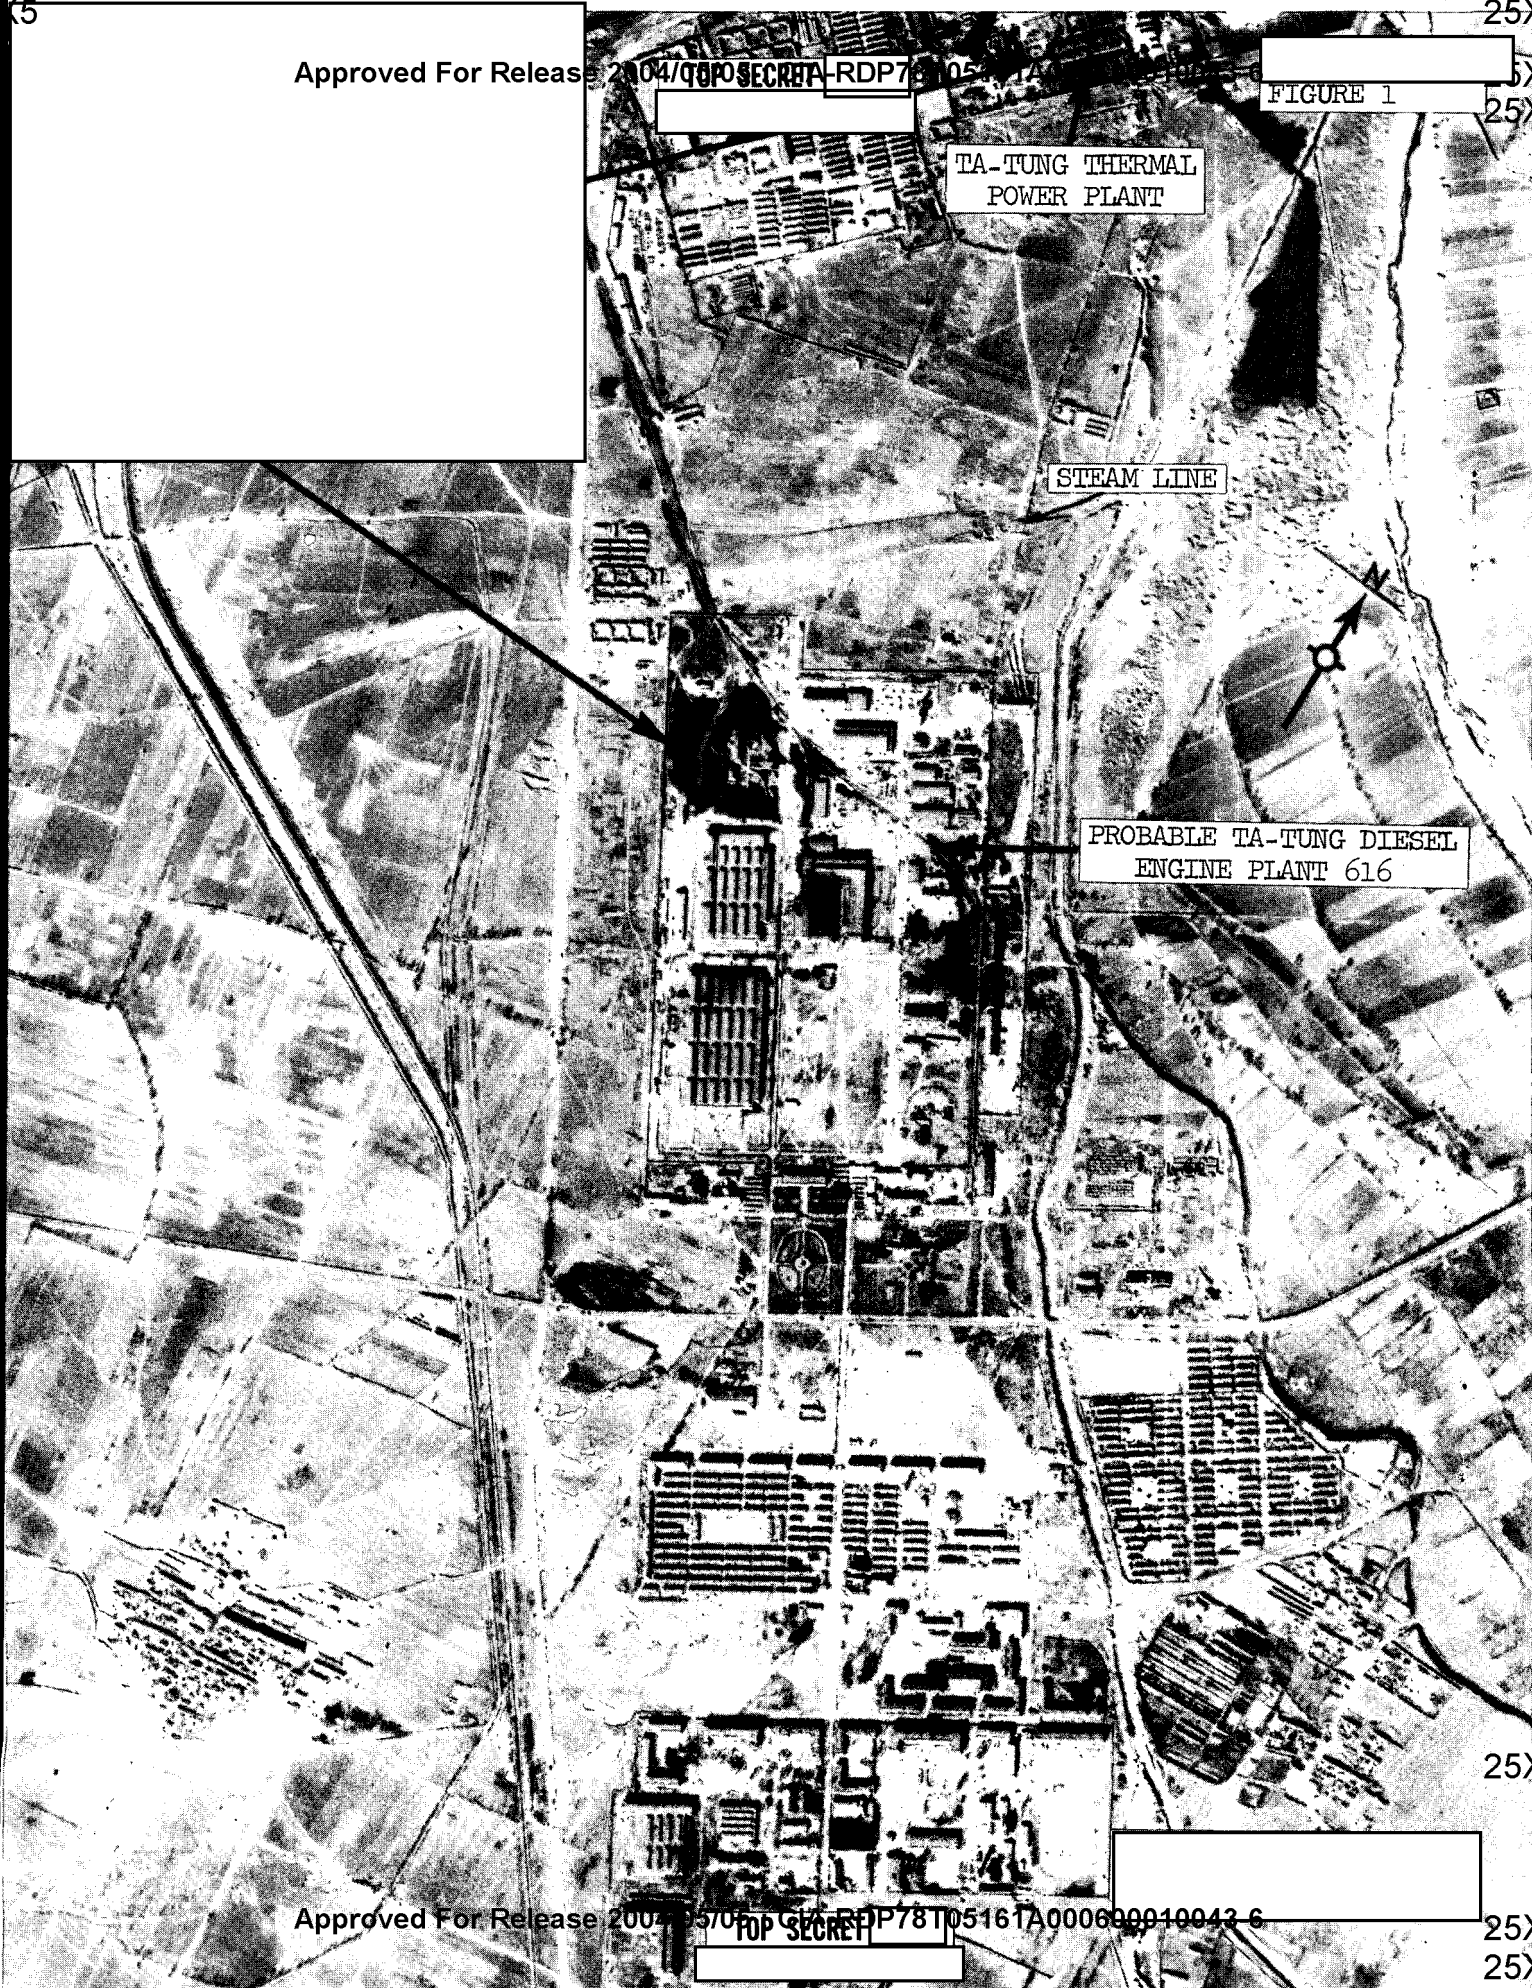
FIGURE 1

A search for the Ta-tung Diesel Engine Plant #616 revealed only one plant that appears capable of such production. It is located 3.6 nm southwest of Ta-tung on the west bank of the Shih-li Ho at coordinates 40 02 30N - 113 12 20E, and consists of two large assembly buildings, a forge/foundry, two large machine shops, possible steam plant, heat processing buildings, and numerous miscellaneous support/storage facilities which are described and annotated in Table 1 and shown on Figure 2. All production buildings and most of the support/storage areas are served by rail spurs that connect the plant with the main railway line between Ta-tung and Tai-yuan. This plant and nearby industries and housing are shown in Figure 1. Power and steam are probably supplied by a large thermal power plant 0.5 nm north of the plant.

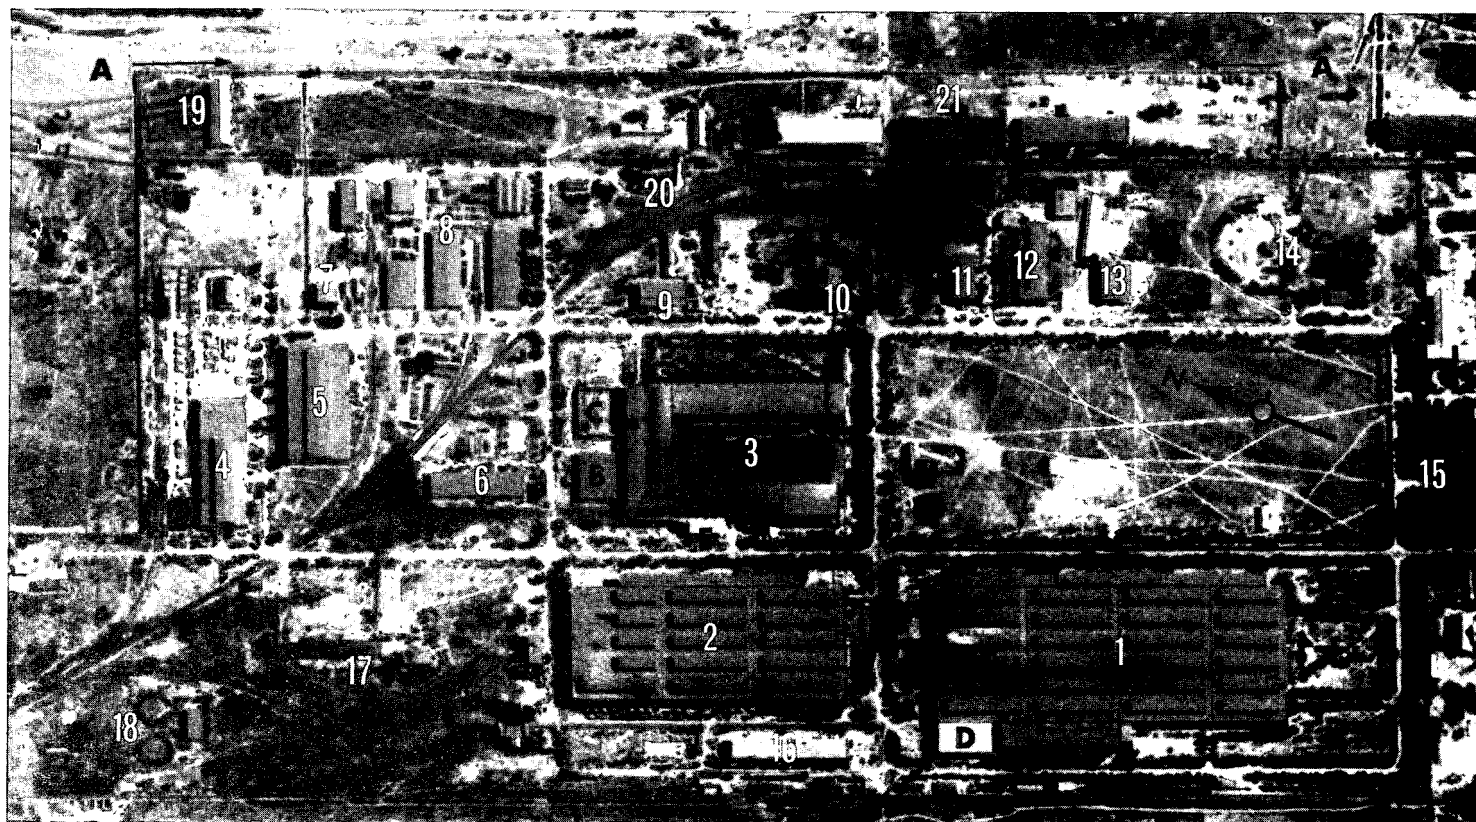
This mission provided poor quality non-stereo photography of the plant. No indications of activity were noted. Several piles of material, possibly sand and coal, were observed near several heat-processing buildings (Items 11 and 12, Figure 2), and the steam plant (Item 10).

Obliquity and haze precluded a detailed photo analysis; however, a wall (Item A, Figure 2) had been built along the eastern boundary of the plant and enclosed buildings 19 and 21 which were previously located outside of the plant proper.

Construction of a small probable storage addition (Item B) to the forge/foundry (Item 3) had begun. The number of crates previously noted did not appear to change. There continued to be a lack of evidences of activity.

No smoke or vapor was observed within the plant. Four buried tanks at the fuel blending station (Item 14) were uncovered since the last mission. Eighteen crates measuring approximately [REDACTED] and eleven much smaller crates were observed east of Item 4. Heavy vapor was observed from building no. 7; no other activity was noted.

Uprights for a second probable storage addition (Item c) to the forge/foundry (Item 3) were in place. No smoke/vapor was apparent.

An addition (Item D) to the northwest corner of building No. 1 was completed since [REDACTED]. This new section may be for storage; the rail line serving the main building enters near this addition. A second addition, a small support type building, was completed just west of the forge/foundry. There are approximately fifteen crates north of building No. 5 and there may be other materials stored east of the fuel-blending station.

There was no significant change in plant facilities. There continued to be an absence of smoke or vapor from the production buildings and the number of crates observed in the storage area north of building No. 5 increased from fifteen to twenty-five.
